ENERGY EFFICIENCY CASE STUDY

Ball Park Floral:

A Neighborhood Staple of 100 years

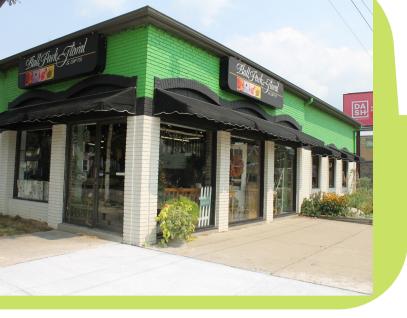
BEFORE

This particular building was built more than 50 years ago as an uninsulated cinderblock building with a flat roof. Upon purchase in 2016, the building had been enhanced with a pointed roof and garage doors; and the sale included an adjacent residentially zoned property as well. The owners have been upgrading the building ever since, including changing LED light bulbs, replacing the furnace and even arranging the floor plan to maximize natural light exposure from the west and south facing windows.

The GR 2030 Districts Energy Assistance Program sponsored an ASHRAE Level "1.5" audit performed by Foresight Management, which uncovered great savings opportunities for Ball Park Floral. The energy conservation measures covered building envelope, mechanics, space use, lighting, a utility analysis and an EnergyStar Portfolio Manager account. The chart shows what Ball Park Floral have undergone to date. Notable Energy Conservation Measures (ECMs) include creative thinking such as maximizing use of space by condensing the three large walk-in coolers, best practices such as EnergyStar Appliances, as well as no-cost fixes such as cleaning the coils of the condenser unit.
